### **DAM SAFETY INSPECTION REPORT**

INVENTORY No.: TX02712

DAM: Indian Lake Dam

CURRENT INSPECTION DATE: November 12, 2025

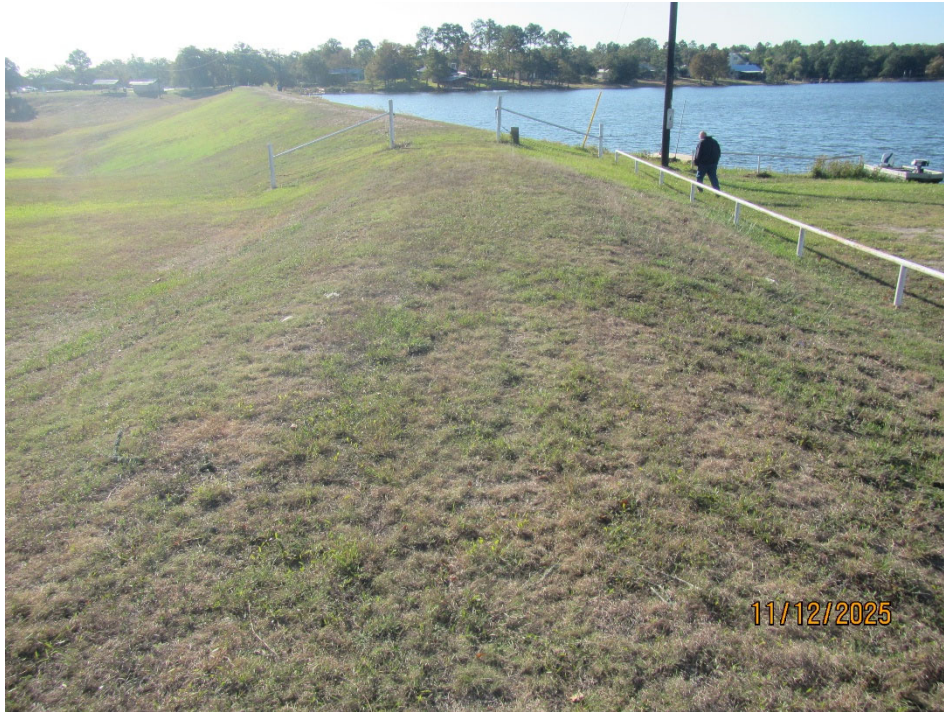
**Photo 1.** View of the crest looking right from the left end of the dam. Note the well-maintained grass cover.

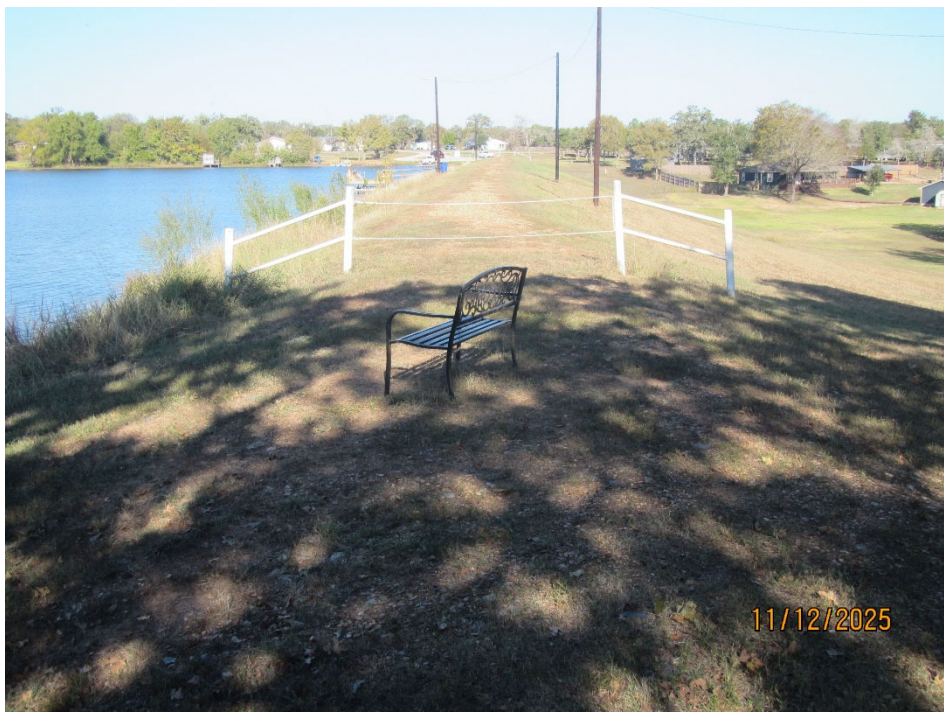
**Photo 2.** View of the crest looking left from the right end of the dam.

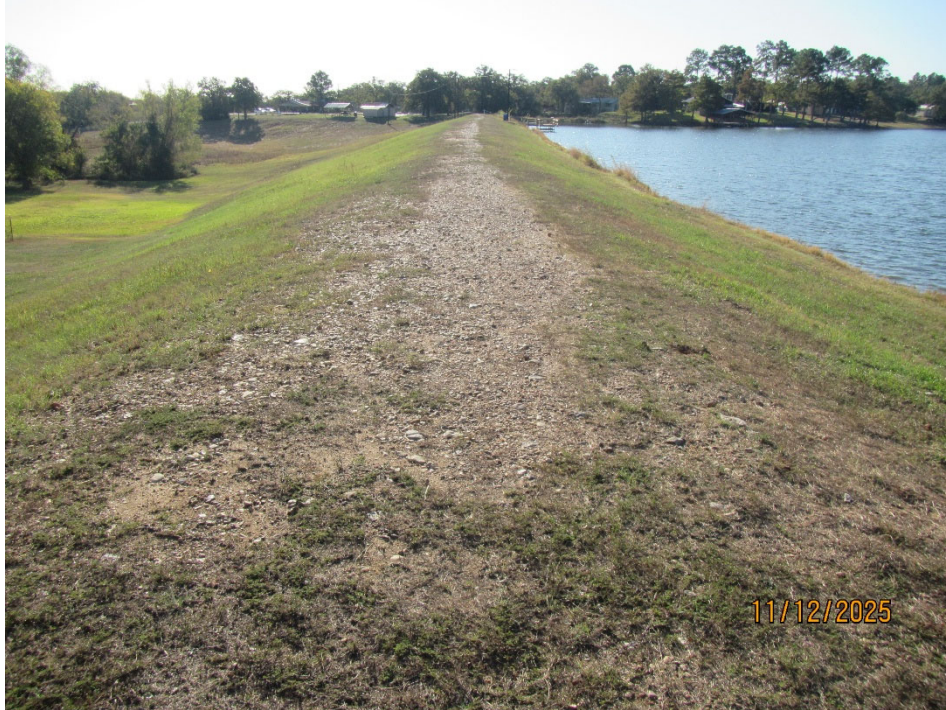
**Photo 3.** View of the crest looking right from the mid-left end of the dam. Note the bare soil area along the crest.

- 3. All overgrown grassy vegetation along the upstream slope should be mowed. Mowing should continue to be performed as needed prior to any future inspections (including owner inspections), and/or typically not less than twice yearly.
  - a. All trees (regardless of size), excessive grassy vegetation, brush, and dry wood debris should be mowed and/or cleared from the spillway (inlet/outlet), debris guard fences, spillway channel, and the downstream area where the two 4-inch drainpipes discharge to ensure adequate flow conveyance.
- 4. A short grass cover should be established over bare soil area(s) primarily along the crest. A short grass cover provides an ideal surface

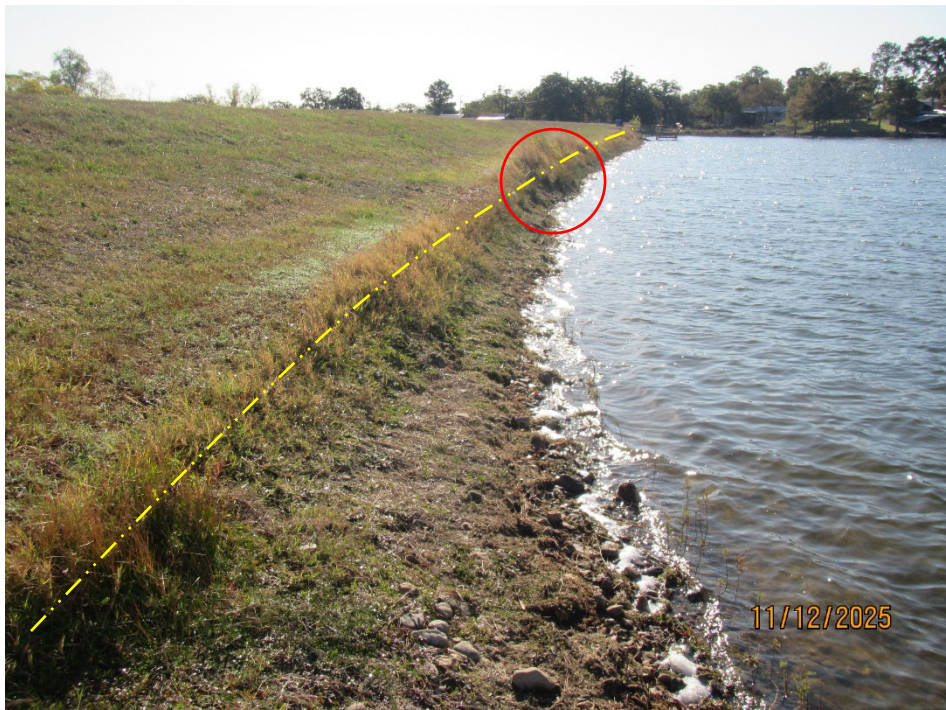
**Photo 4.** View of the upstream slope looking right from the near left end of the dam. Note the slight uneven shoreline (circled) and taller vegetative growth along the approximate normal pool level (dashed line).

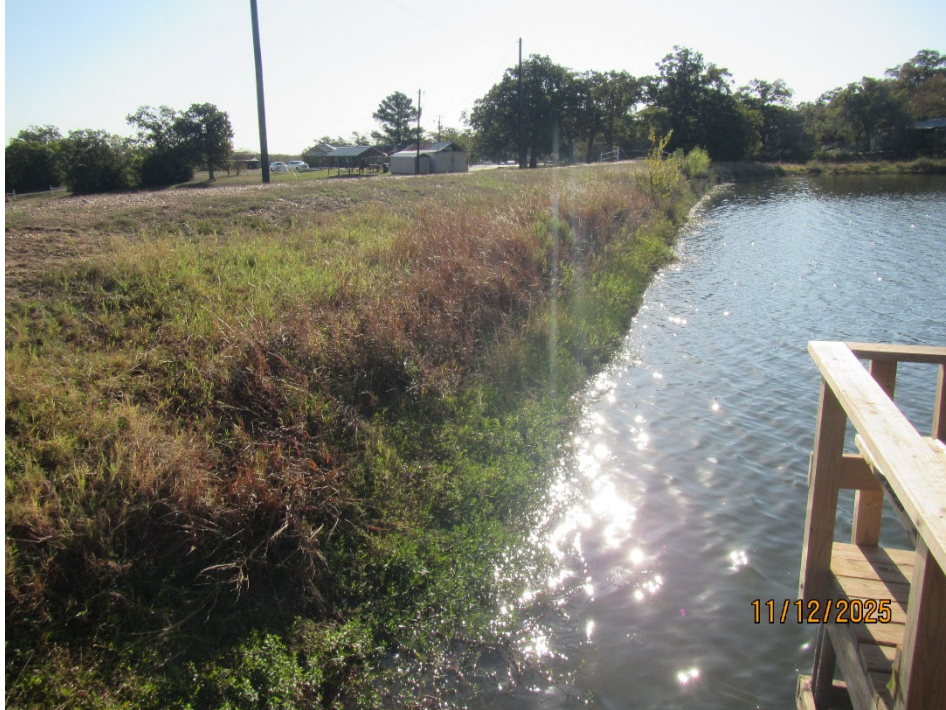
**Photo 5.** View of the upstream slope looking right from the middle of the dam. Note the taller grass growth along the right end of the slope.

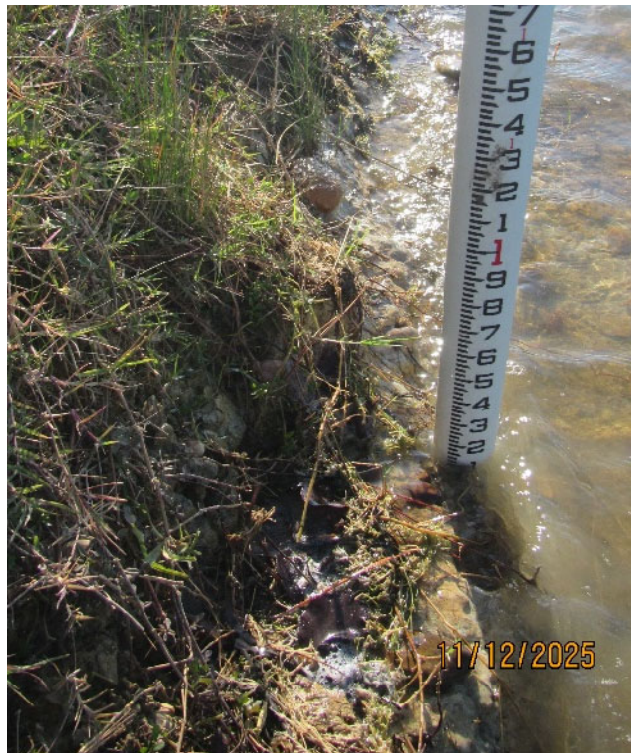
**Photo 6.** View of minor benching occurring along the mid-left end of the upstream slope along the shoreline. Benching in this area measured approximately 1-foot high.

- d. Monitor benching erosion along the upstream slope.
- e. Routinely monitor and remove any overgrown grass/brush growth and debris along the debris fence traversing the spillway to allow for proper conveyance.
- f. Routine safety inspections should be conducted on a periodic basis and immediately after a significant rain event to evaluate the condition of the structure and detect and address problems before they progress to a serious level. These actions will minimize cost of dam maintenance and repair activities as well as minimize risks and liabilities associated with dam safety issues.

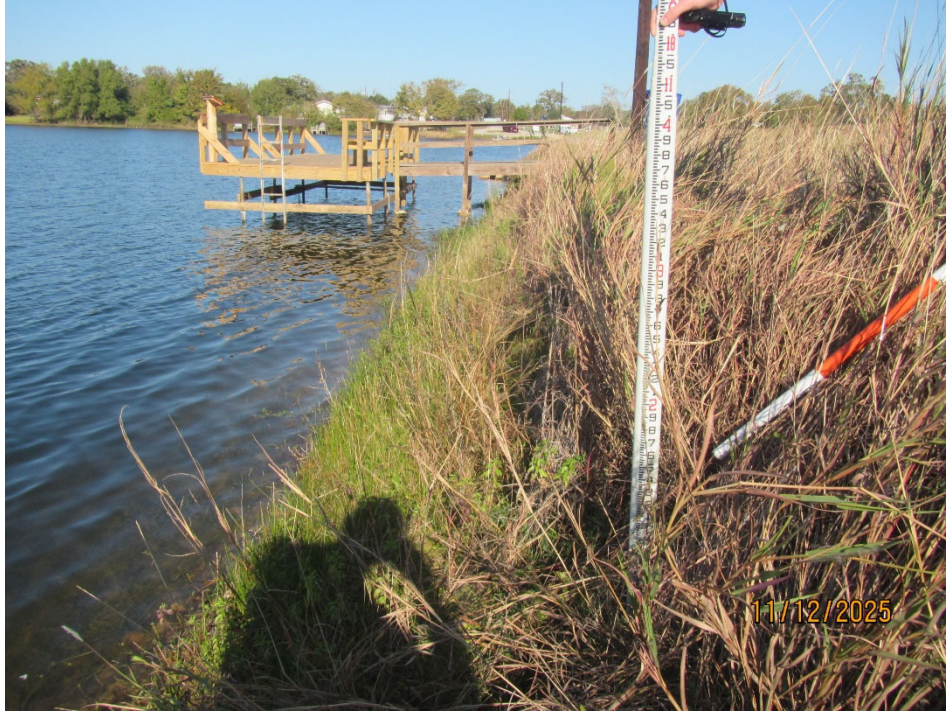
**Photo 7.** View of benching occurring near the right end the upstream slope looking left. Note the taller grass growth obstructing the approximate 1.5-foot high bench along the approximate normal pool elevation.

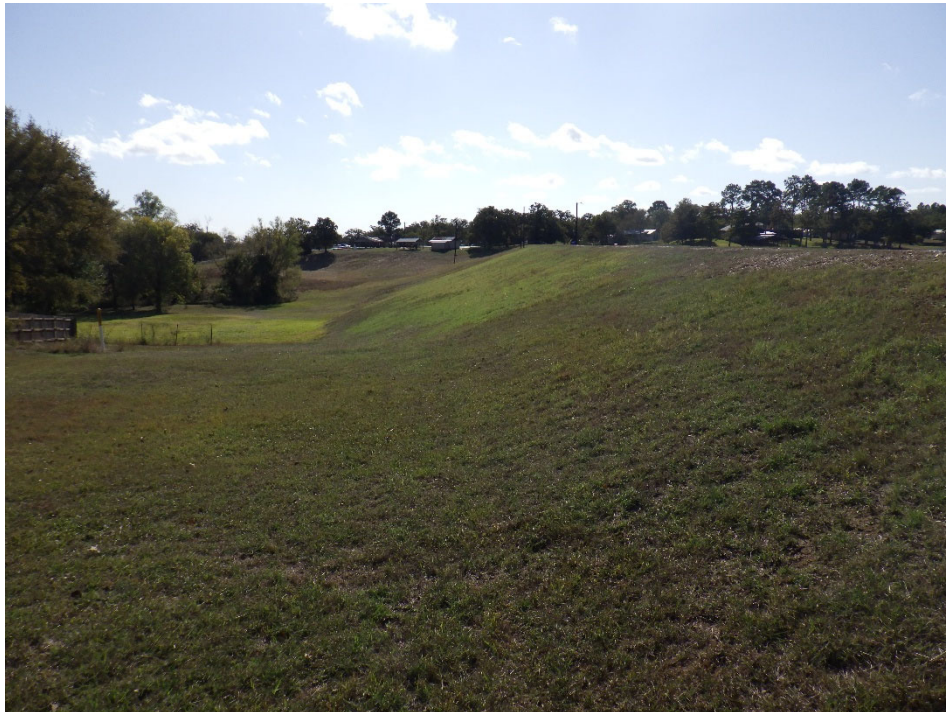
**Photo 8.** View of the downstream slope looking right from the near left end of the dam. Note the well-maintained grass cover.

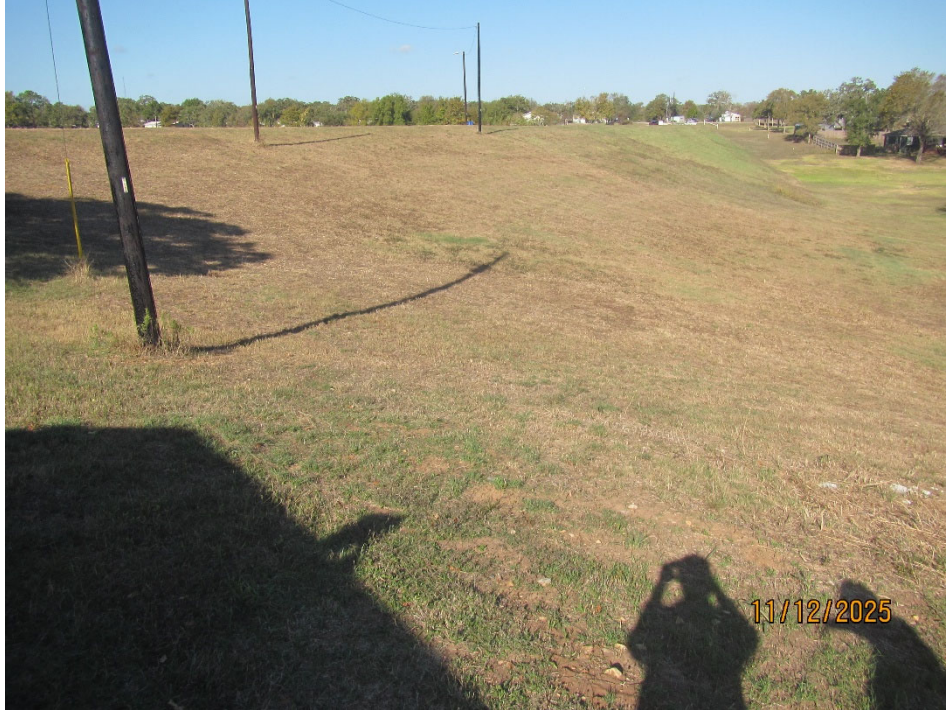
**Photo 9.** View of the downstream slope looking left from the right end of the dam. Note the well-maintained grass cover along the previously noted damaged areas.

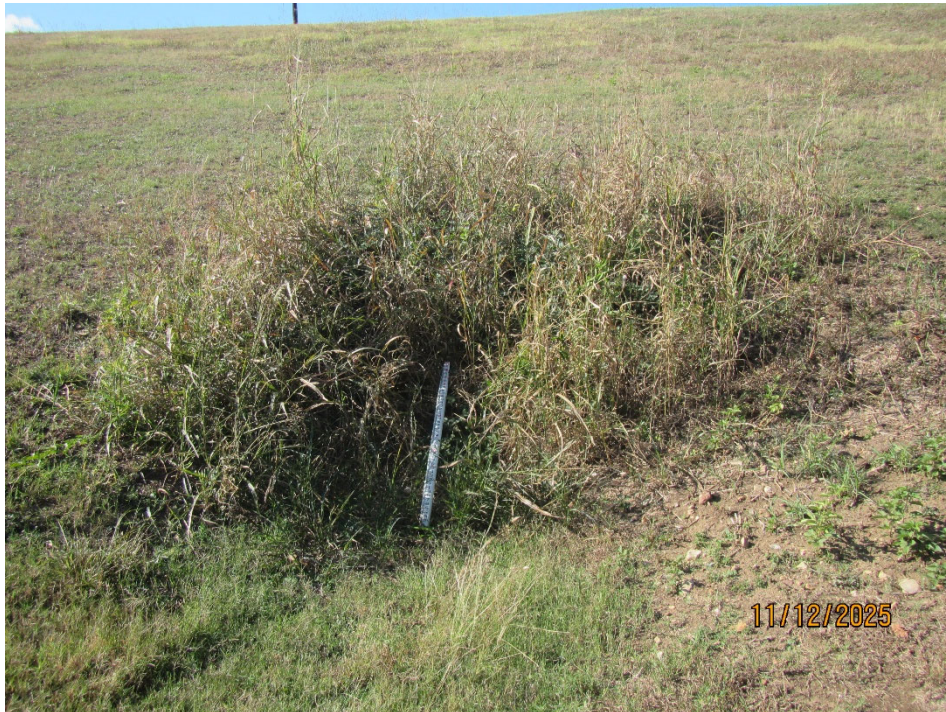
- The previous report noted a slide on the lower downstream slope toe area that is in-line with the siphon pipe; however, it could not be confirmed if this area is in fact a slide occurring or simply a low uneven area where it is believed that the siphon pipe outlet is located.

**Photo 10.** View of an area believed to be the location of the siphon pipe outlet but noted in the previous report to be a new slide. Note the outlet was not observed and the area was overgrown with grass.

5. The siphon pipe outlet should be located and inspected. In addition, the overall operational condition of the siphon pipe system is unknown and should be further investigated. If the siphon is functional then it should be exercised at least on an annual basis to ensure it is in good working order and capable of lowering/draining the reservoir should an emergency situation ever warrant such. If the siphon has not been operated for a substantial period of time, it is recommended that your PE devise a plan to assess the functionality and ensure that the siphon pipe system is working properly.

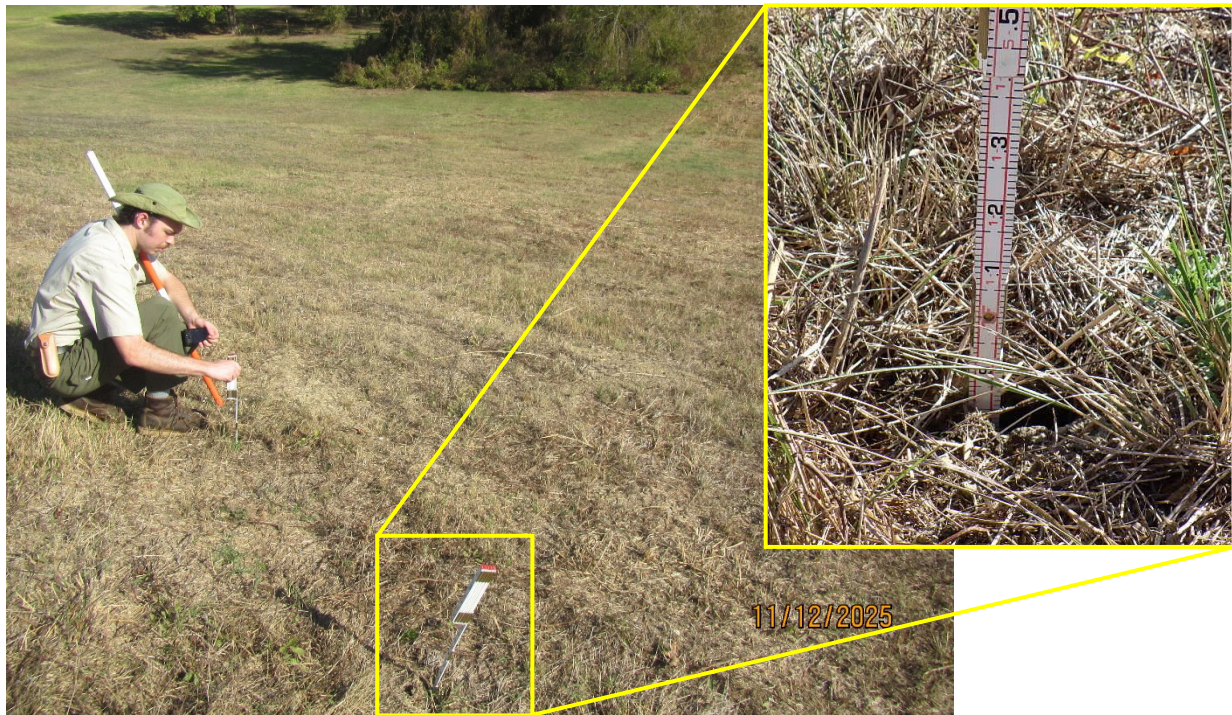
- Several longitudinal cracks were observed along the lower downstream slope at the right end of the dam. The most significant crack measured approximately 11-inches deep. This general area of the slope also appears to be where the drainage blanket had been installed.

**Photo 11.** View of an area along the lower downstream slope at the right end of the dam where several longitudinal cracks were observed. Note the most significant crack measured approximately 11-inches deep.

- a. Monitor longitudinal cracks along the lower downstream slope.
- b. Seal crack along the siphon concrete anchor block and monitor for any further movement.
- c. No active seepage was observed along the downstream toe area; however, the possibility of seepage has been documented in past inspections. The downstream toe area should continue to be kept well-maintained and routinely monitored for seepage. If seepage is located during a routine inspection, then the normal amount

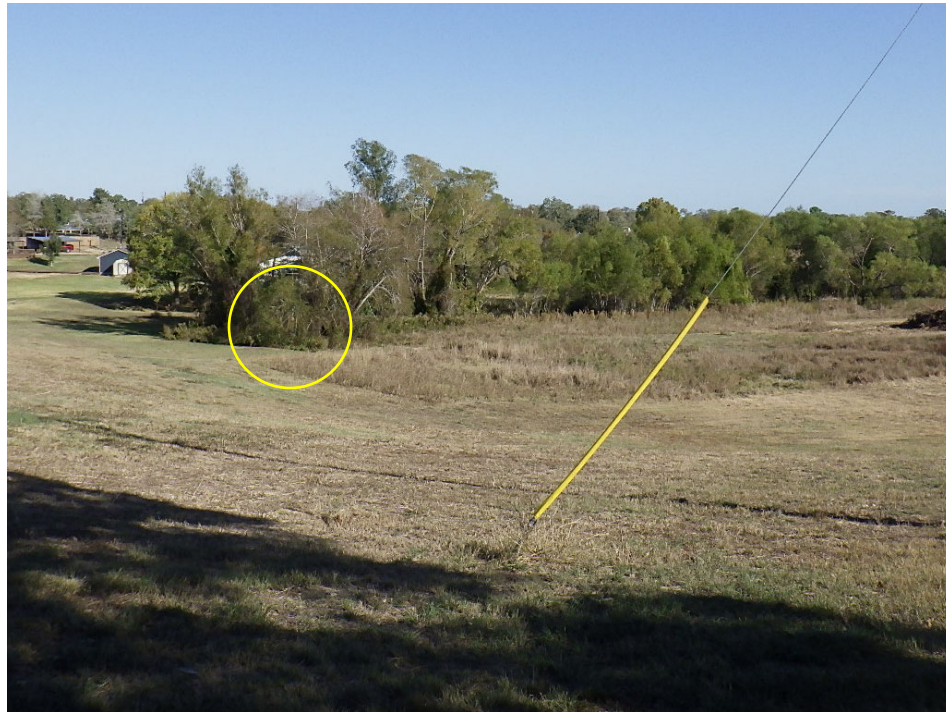
**Photo 12.** View of the dense vegetative growth along the downstream toe area where the two 4-inch PVC pipes (circled) discharge.

6. The two 4-inch drainpipes along the downstream toe area should be sloped to properly drain away from the dam. The surrounding area of the pipes should be cleared of all obstructive vegetation and to routinely monitor flow.

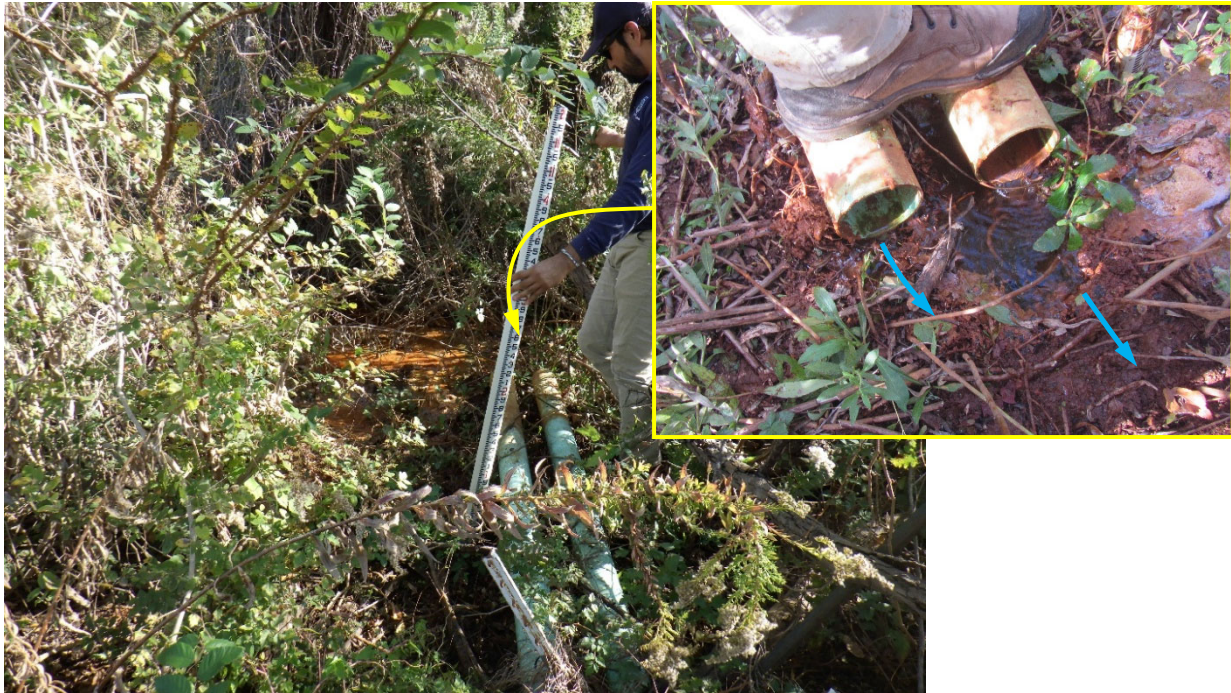
- Two 4-inch diameter PVC drainpipes were observed within a densely overgrown area of the downstream slope toe near the center of the dam. This drainpipe system was installed during the repairs of the historic slide that occurred in the early 2000's. Both pipes were noted to be

angled slightly upwards, creating negative drainage and not properly draining. Flow was not measured during this inspection.

**Photo 13.** View of the two 4-inch PVC drainpipes within the overgrown downstream area. Note the pipes were angled slightly upwards; therefore, creating negative drainage and not properly draining.

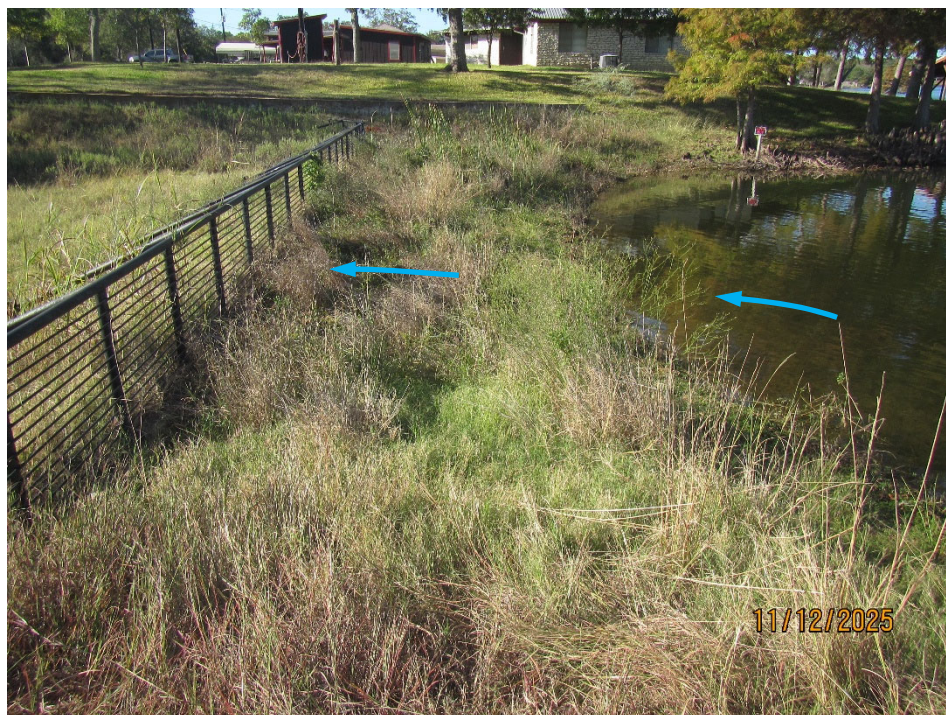
**Photo 14.** View of the spillway inlet looking right from the left end of the spillway channel. Note the tall grass growth along the inlet just upstream of the debris guard fence. The direction of flow is noted by the arrows.

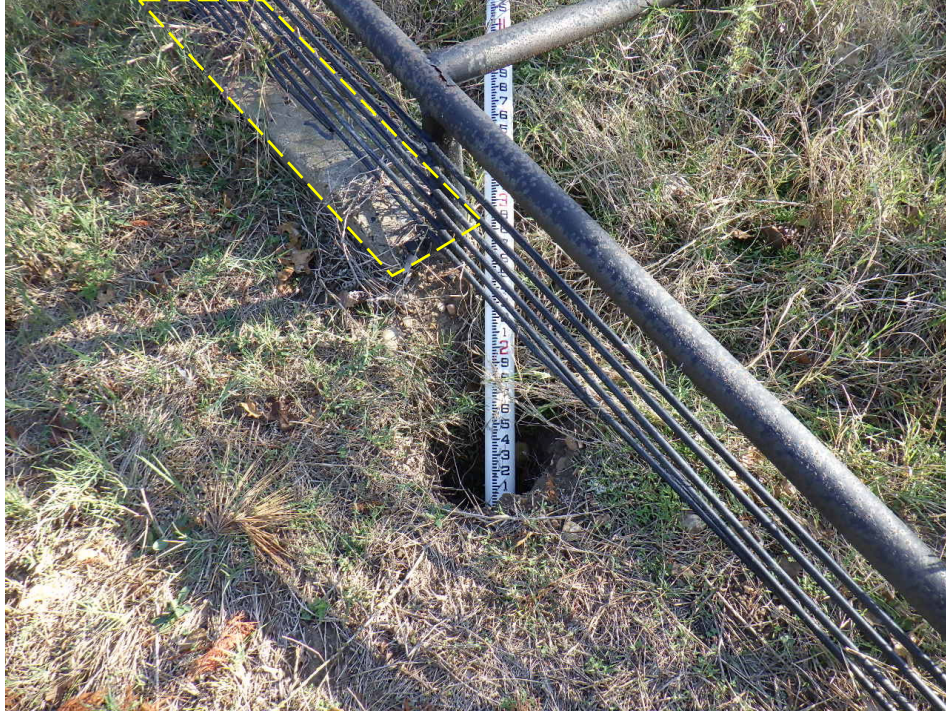
**Photo 15.** View of burrow/hole along the debris guard fence and near the right end of the concrete weir (dashed line). Note the burrow/hole measured approximately 1.4-feet deep.

7. The burrow/hole observed along the spillway inlet should be backfilled and properly compacted with non-dispersive fill and a grass cover should be re-established.

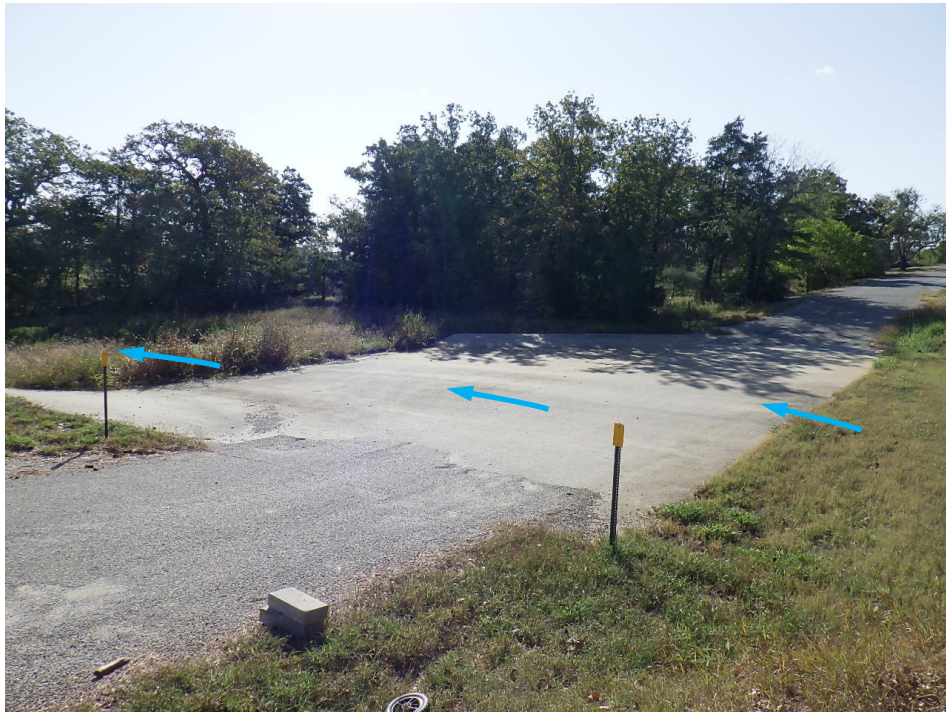
**Photo 16.** View of the spillway channel/roadway crossing approximately 320-feet downstream from the spillway inlet. The direction of flow is noted by the arrow.

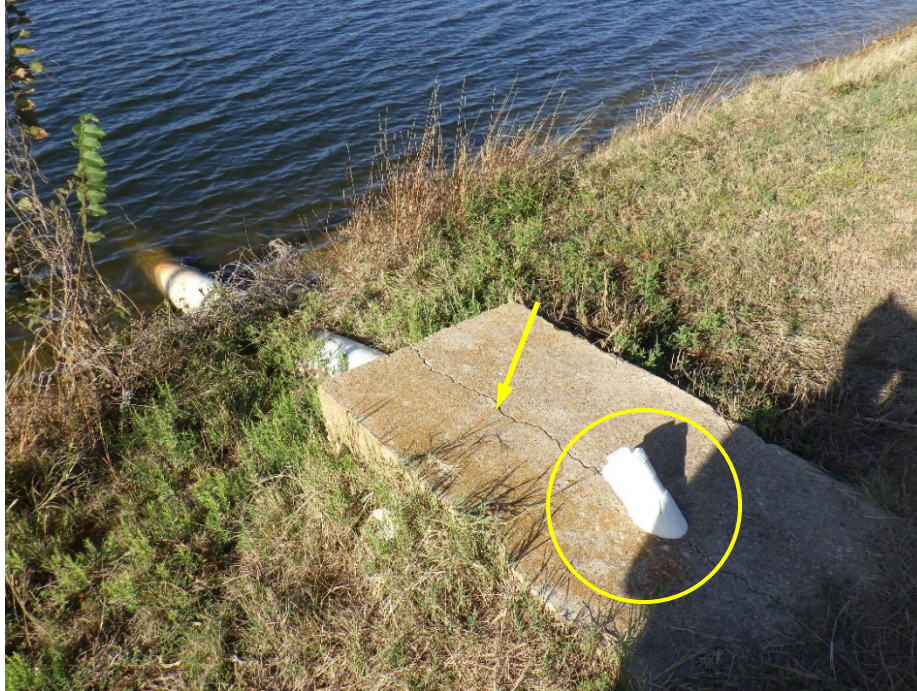
- The 12-inch diameter Polyvinyl Chloride (PVC) siphon pipe is located near the mid-right portion of the dam.
- A previously noted crack was still present along the concrete anchor block.
- The outlet of the siphon pipe was not observed during this inspection; however, it is assumed to be located at an overgrown area along the downstream toe area.
- The operational condition of the siphon pipe is unknown.

**Photo 17.** View of the siphon pipe and concrete anchor block with air inlet plug (circled) near mid dam on the upstream slope. Note the crack (arrow) on the anchor block is still present as observed in previous inspections.

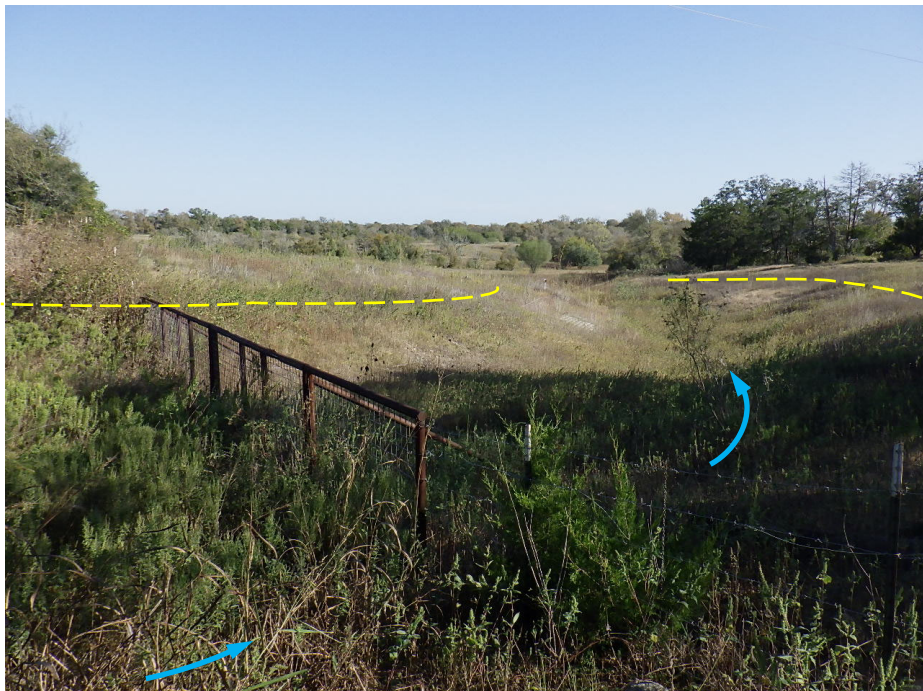
- Flows from the spillways travel along a well-defined channel bed with scattered small brush growth.
- A tubular framed fence was observed just downstream of the spillway channel/roadway crossing. Grass and brush vegetation were observed growing along the fenceline.
- The channel meanders in an easterly direction along an unnamed tributary for approximately 0.5 miles downstream before converging with Gravelly Creek.
- The downstream channel was found in fair condition.

**Photo 18.** View of the downstream channel looking downstream from the spillway channel/roadway crossing. Note the brush and grass growth along the fence traversing the spillway channel. The direction of flow is noted by the arrows.
